O.ht2 Trip Code

This document pertains to size 1,2, and 3 Unidrive SP drives

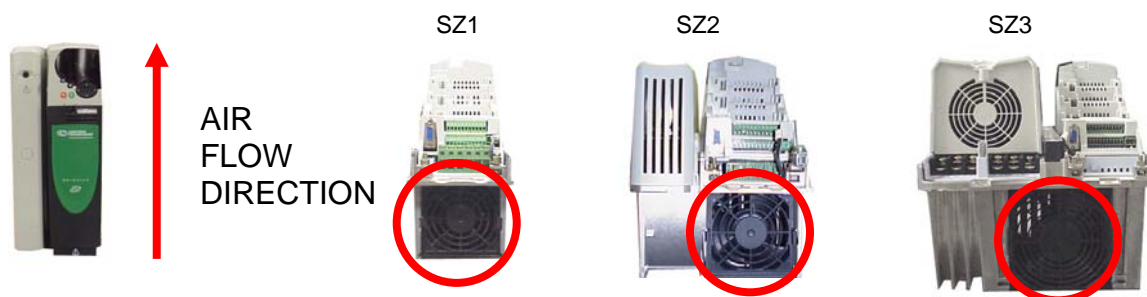
It is imperative to ensure there is good air movement through the drive heatsink. Check fan operation and airflow. Inspect the heatsink cooling fins on the drive. Excessive debris or an impasse due to environmental build up will cause the drive to over heat.

The fans for drive sizes 1, 2, and 3 are located on the bottom of the drive. Airflow should go towards the top of the drive. The pictures of the fans can be seen on the next page.

If you find a clogged or defective fan they can be replaced. **We only recommend experienced engineers or technicians attempt repairs on our drives due to safety concerns.** If you would like, a certified CT Technician can repair the drive for you. Contact 1-800-367-8067 and ask for Repairs or Technical Support.
