This Application Note is pertinent to the Unidrive SP, Commander SK and Affinity Families

Over Voltage Trips on Power Up

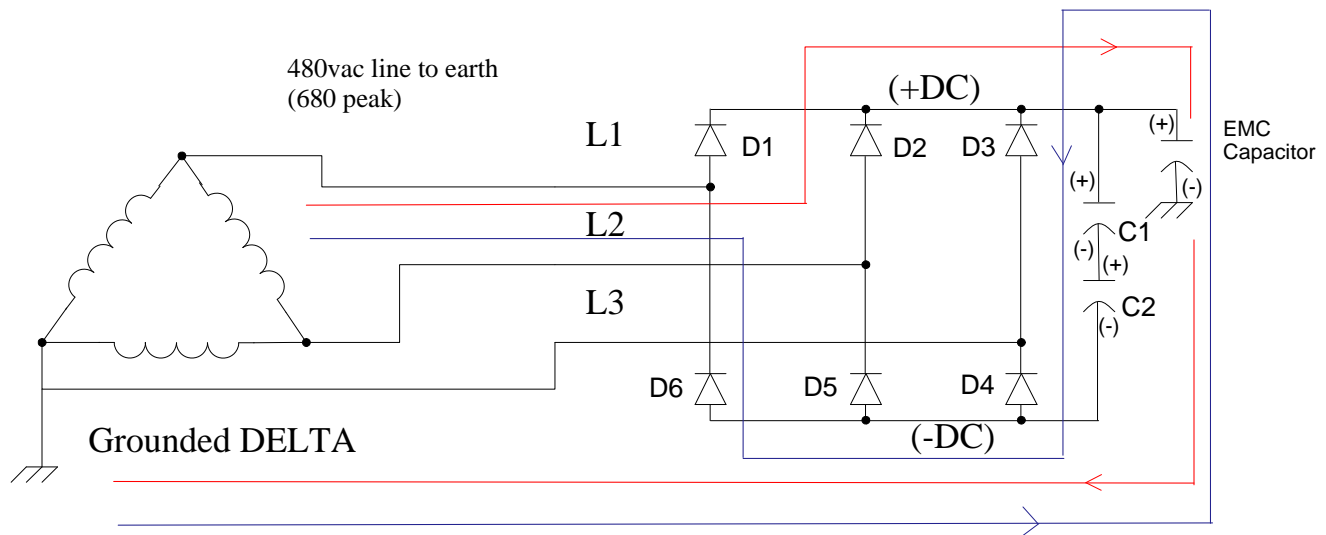
The drawing below shows the basic charge paths of the “voltage doubler” circuit. When line L1 goes positive, it charges the EMC capacitor (thru diode D1) to the peak of the ac line (680vdc for a 480vac line) with respect to earth common. When L1 goes negative with respect to earth, the negative side of C2, is “pulled down” towards the negative peak voltage of L1 (-680volts) causing charge stored in the EMC capacitor to be transferred to the bus capacitors, charging them to the dc bus trip level. This is somewhat simplified but does demonstrate the current paths that cause the problem. If the EMC capacitor is removed, you can see that the path no longer exists and the over voltage trips will stop.

The solution to the problem is to simply remove the EMC capacitor. This capacitor is a requirement in Europe but not in the USA.

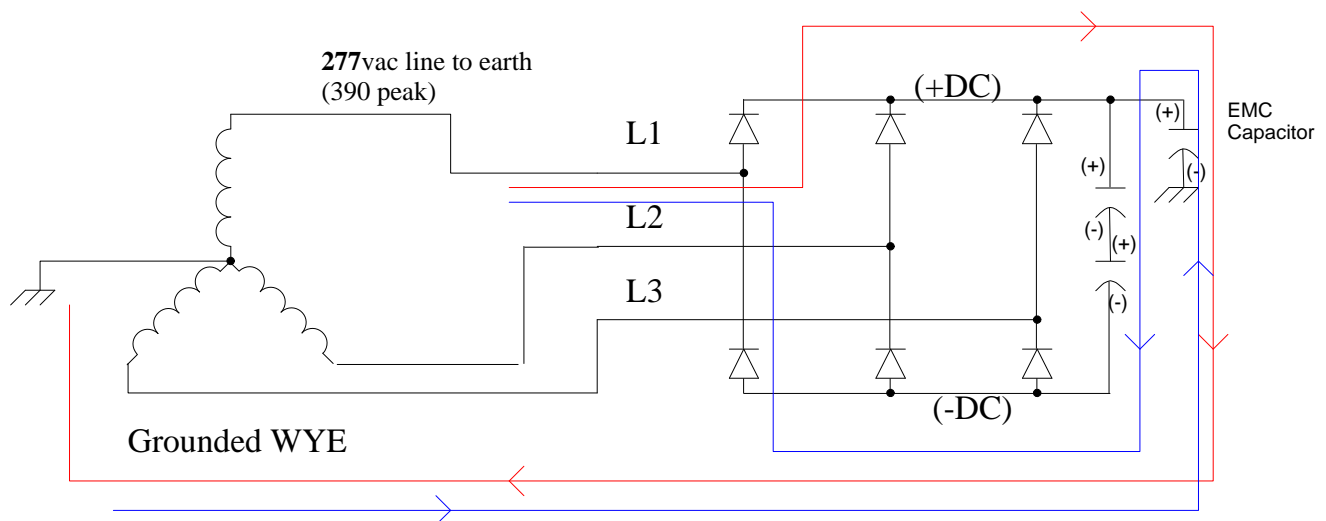
In the grounded wye connection shown below, the same process occurs with the exception that the peak voltage with respect to earth ground is only 390 volts instead of the 680 volts as above. In this case the energy transferred will not be enough to cause the dc bus to charge to the over voltage trip level.

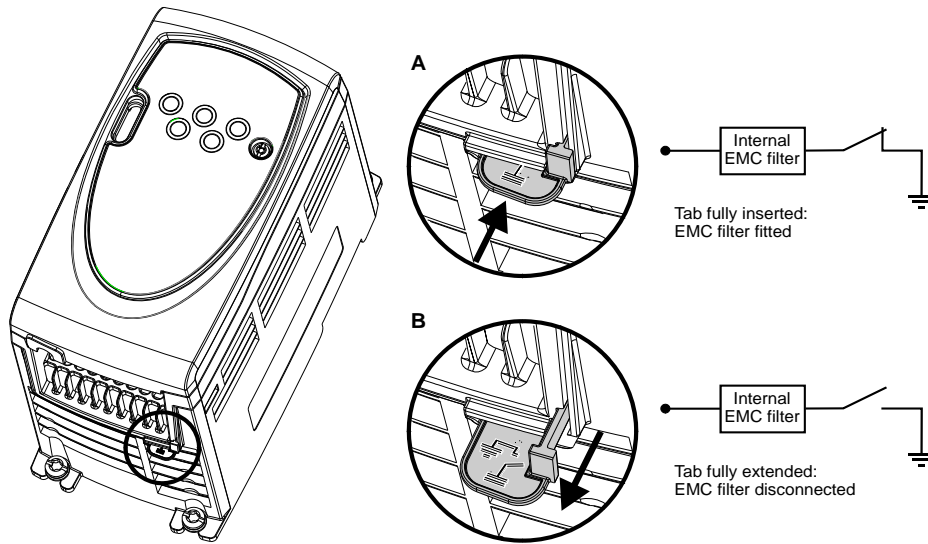
The other two configurations, ungrounded Delta and Wye connections do not typically exhibit the over voltage charging. In rare cases if the coupling capacitance to earth ground in the power system is unusually high on one phase a charging path could be created. In this case, (in fact any configuration other than grounded Wye) the capacitor should be removed.

Commander SK A thru D uses pull tab
