This Application Note is pertinent to the Unidrive SP, Commander SK and Affinity Families

Over Voltage Trips on Power Up

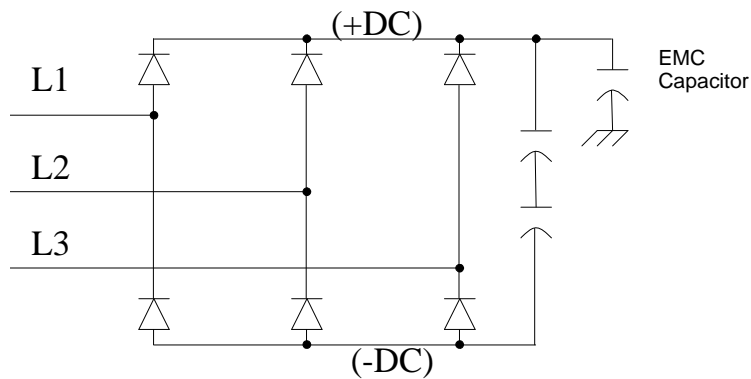
Over voltage trips occurring immediately after a power up results from a voltage doubling action caused by the "EMC" Filter Capacitor¹ supplied in the drive when applied to a grounded Delta power system. Although in rare cases a floating Delta or Wye system will exhibit the same problem .

These transformer configurations feed 3 phase power to our drive's "rectifier front end" as shown below. As can be seen, the 3 phase rectifier feeds a DC bus with the EMC filter providing a high frequency shunt path from DC+ to Earth.

The solution to the problem is to simply remove the EMC capacitor. This capacitor is a requirement in Europe but not in the USA.
